Redfern Community Safety Audit (2010)

1.1. Redfern Safety Audit

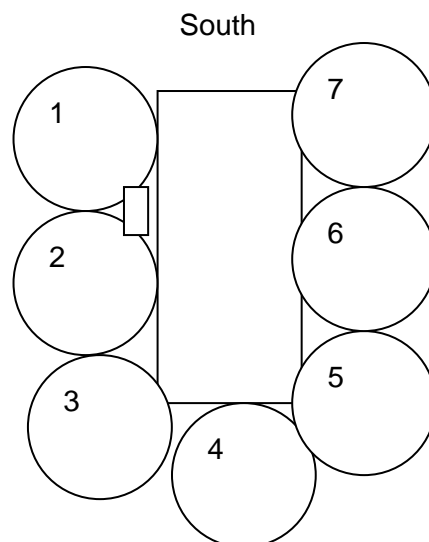
Grounds:

1. Poor lighting
Broken pipe
Trip hazard
Fire door needs putting back
Hidey holes, very poor lighting

2. Entry water on top of holes on pavement to entry
Never clean
Lighting in mailbox area is not as bright as should be
Entry doors slam loudly when people exit. (need adjustment).
Notice board glass broken (a hazard).

3. Outdoor table – seats damaged.
Shrubbery too dense (people can hide)
Need sharp plants (Eleanor's garden)
4. Trip hazard in lawn area
Container needs removing
Light on Northern end doesn't work.
5. 7. 3 lamps need replacing
5. Shrubbery needs cleaning out (rats and safety)
6. At entry – hidey hole
Door to refuse room is broken
Rubbish is putrid.
